DISASSEMBLY INSPECTION AND OVERHAUL

X-22A GEAR REDUCTION AND PROPELLER ASSEMBLIES

HAMILTON STANDARD
DIVISION OF UNITED TECHNOLOGIES CORPORATION
WINDSOR LOCKS, CONNECTICUT 06096

**JULY 1978**

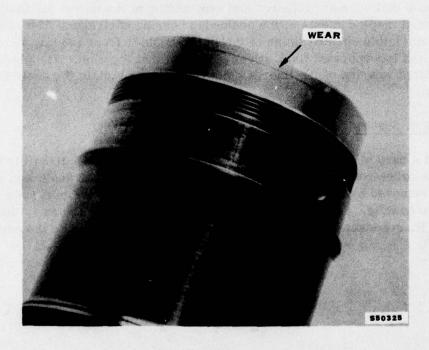
Figure 11. Propeller Barrel Tailshaft

# Propeller Barrel - L.H. - P/N 592014-2

The barrel tailshaft exhibited a band of wear from contact with its corresponding P/N 582555-2 shaft seal. The wear depth was superficial and was removed by lapping without significantly reducing the thickness of the chrome surface coating. See Figure 11 for typical appearance - Figure 4, the Gear Reduction - L.H. subassembly drawing, for orientation of the barrel in the assembly.

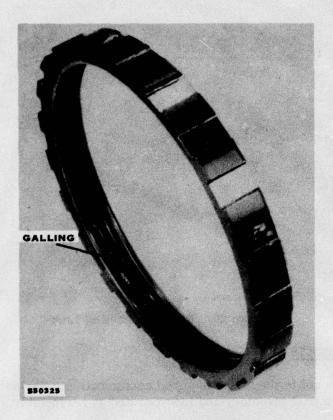
Figure 25. Retaining Nut

#### Retaining Nut - P/N 582526

The nut internal buttress type thread was severely galled from contact with the P/N 592014-1 barrel, as reported above. See Figure 25 for documentation of the galling and Figure 3, the Gear Reduction - R.H. subassembly drawing, for orientation of the nut on the barrel. A replacement nut was obtained from the four residual assemblies and electrofilmed (per HS 248, Class 42, Type A1). Experimental engineering change E121785, dated 18 November 1977, requires electrofilming of all future parts.
